# FORM B – BUILDING

**Town:** Dartmouth

**Address:** 82 Bryant Street

DAR.491

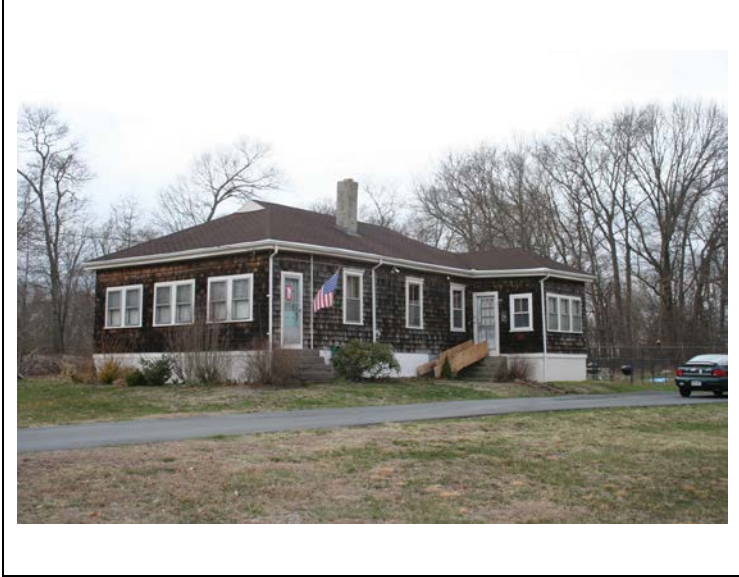
## Photograph

**Condition:** Fair

This is a 1-story rectangular plan low pitch gable-on-hip roof house structure partly on a parged stone foundation. A small second-entrance wing juts from the right side of the house near the rear. Tax records state this house was built in 1781. It is possible that a small Cape Cod structure is buried under the complete makeover of the house that probably occurred in the early 20<sup>th</sup> century. The front façade appears to originally have been a porch, later enclosed. The porch enclosure may have been done at the same time as the rear addition as the 3 paired 2/1 windows across the front of the façade & the single 2/1 window located on the left side of the enclosure appear to be identical to those 2/1 windows located in the rear addition. The windows located on both sides of the structure are larger and capped with a distinctive trim board. These would appear to be original to the structure. There appears to be a parged brick chimney located on the middle right slope of the main block. The entrances are located on the right side of the structure. The structure is shingled and rests on parged stone with the exception of the enclosed front porch and the wing that are probably on posts enclosed with boards.
